Since April 1972 a modified windshield header molding and modified guide bearings have been installed in these vehicles.

Production Breakpoint

Type 107.043 as from Chassis End No. 006 914

Type 107.044 as from Chassis End No. 004 182

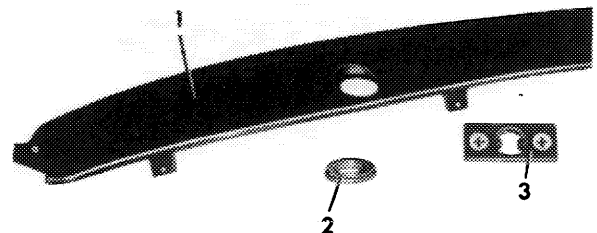
R 68/7611

When installing the modified windshield header molding in vehicles with lower chassis end numbers, the two guide bearings and the two washers must also be replaced.

- 1 Unscrew windshield header molding (1) from front panel frame.
- 2 Remove both guide bearings.
