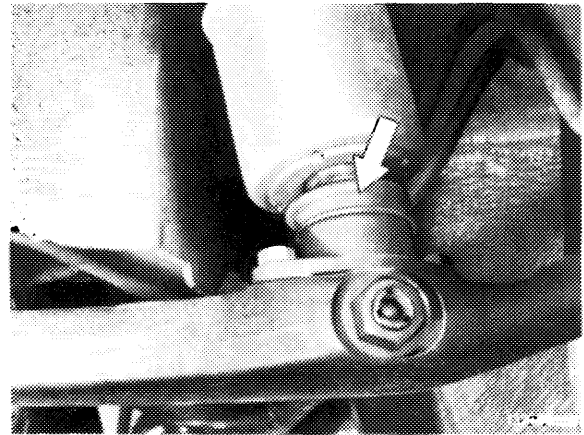
- Carefully check sealing and condition of rubber sleeves for ball joints on tube shocks of front and rear axle.

Ball joint on front axle

**Note:** In the event of a leaking rubber sleeve, replace respective joint immediately since penetrating dirt will result in early destruction of joint. The rubber sleeve alone cannot be replaced.

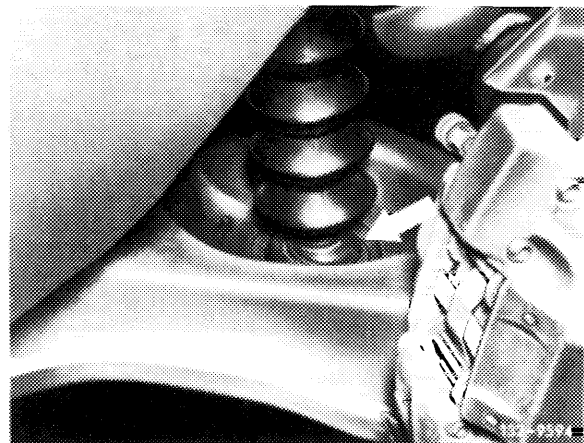
Ball joint on rear axle
