Three-point belt with automatic reel

made by Klippan

Model 116.020	up to chassis end No. 075 993
116.024, 025	072 157
116.028, 029	036 858
116.032, 033	058 918
116.036	001 650

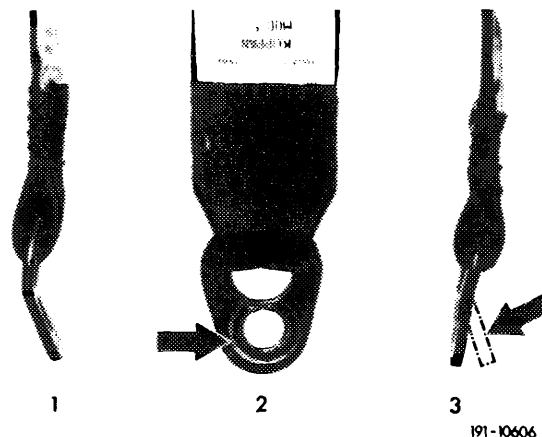
Belt end fitting is deformed, that is, the formerly off-set end is now straight.

Belt end fitting is damaged by fastening screw (arrow).

In addition, the plastic coating of the lock catch may show chafe marks and there may be bright spots at belt in range of belt guide fitting and catch.

- 1 Belt end fitting undamaged
- 2 Belt end fitting damaged
- 3 Belt end fitting deformed during an accident

If the belt end fitting of the safety belt is damaged in the course of an accident, replace complete safety belt.

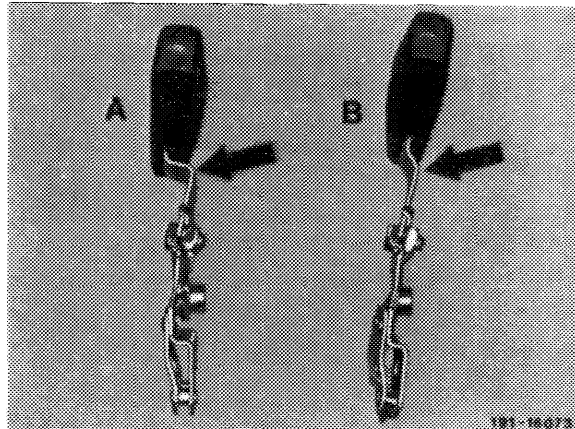
1 Lock with holder begins to stretch. Driver's seat can still be correctly adjusted.

- A lock undamaged
- B lock deformed by accident

**Remedy:**  
Exchange lock and holder.

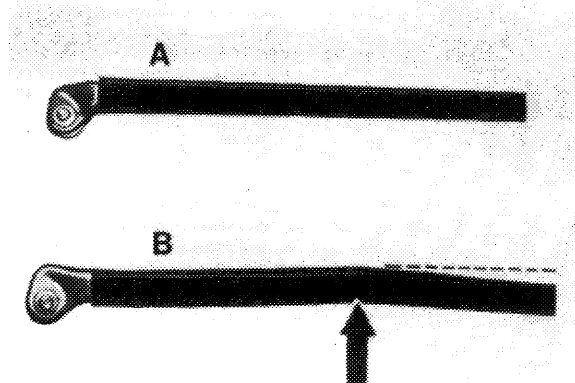
2 Holding rail deformed.  
Driver's seat can no longer be adjusted.

- A holding rail undamaged
- B holding rail deformed by accident

**Remedy:**  
Replace complete safety belt as well as damaged holding rail.
